HOWTO

REMOVE ZIRCONIA CROWNS

Using KOMET's 4ZR diamonds for efficient zirconia crown removal.

by DR. SAM SIMOS

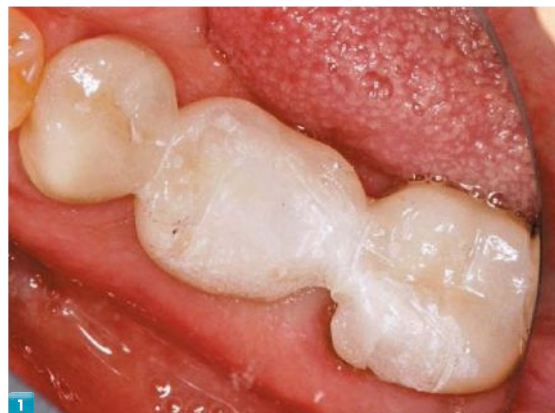
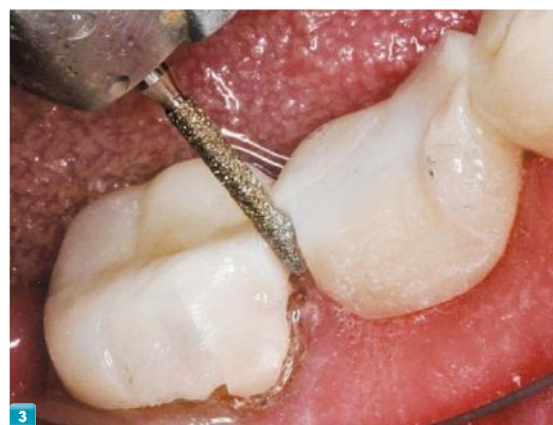
4ZR DIAMOND CROWN CUTTER FEATURES

- Special bond to ensure permanent embedding of the diamond grains
- Optimal substance removal
- Extended service life

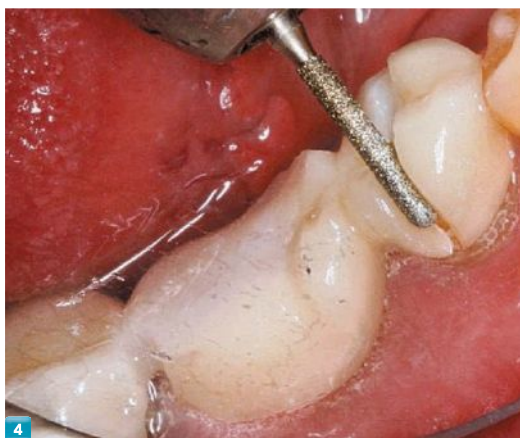
1. Fractured porcelain from the buccal portion of a three-unit zirconia bridge.
2. An initial cut was made at the thickest portion of the bridge at the distal bar of the substructure.
3. A secondary cut was made at smaller anterior portion of the bridge.
4. Care was taken to not go beyond the zirconia material and cut into the tooth.
5. A final cut was made to separate the bridge.
6. An adequate enamel layer and excellent function in the final zirconia bridge.

STEP 01 As the bridge was securely attached to both anterior and posterior abutments, the 4ZR bur was selected for reduction and removal of the zirconia substructure. An initial cut was made at the thickest portion of the bridge at the distal bar of the substructure (Fig. 2).
